# 海南発電所2号機の電流検出器からの発煙、発火の概要

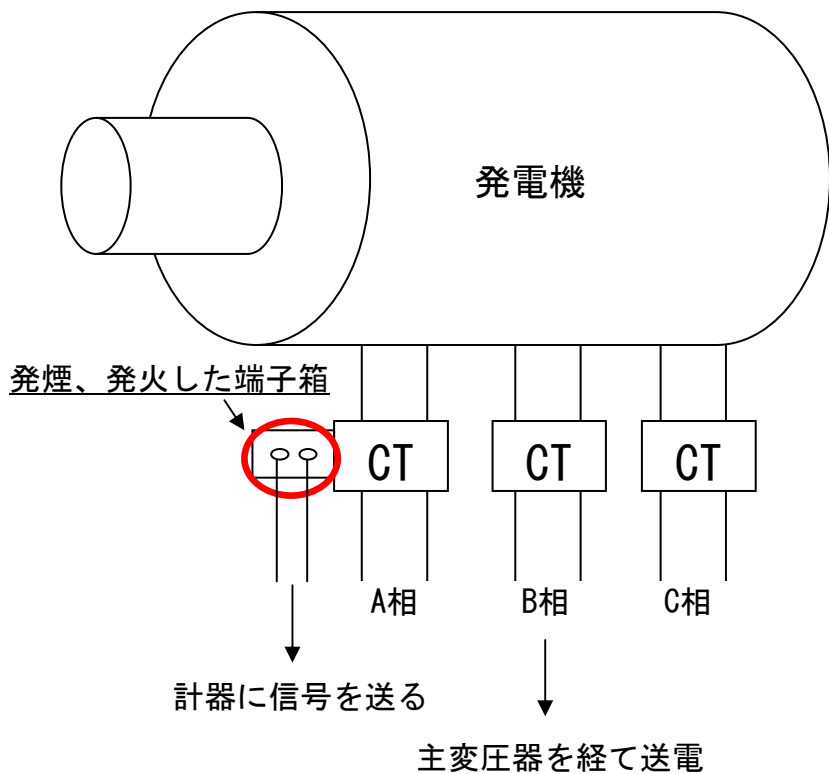
## 発煙、発火した端子箱内

- 発煙、発火前の写真** (Photo before smoke and fire): A photograph of the terminal box with a red circle highlighting the fault location.
- 発煙、発火したケーブル接続端子** (Cable connection terminal where smoke and fire occurred): A close-up photograph of the terminal showing a red spark or fire.
- 消火後の写真** (Photo after fire): A photograph of the terminal box after the fire has been extinguished, showing significant damage and charring.
