Submission of a “Report on Failure/Event of the Nuclear Installation” for Takahama Unit 4 (Subject: Takahama Unit 4 Automatic Reactor Trip Following Automatic Generator Trip)

March 9, 2016

The Kansai Electric Power Co., Inc.

# Takahama Unit 4 Automatic Reactor Trip (Causes/Corrective Actions)

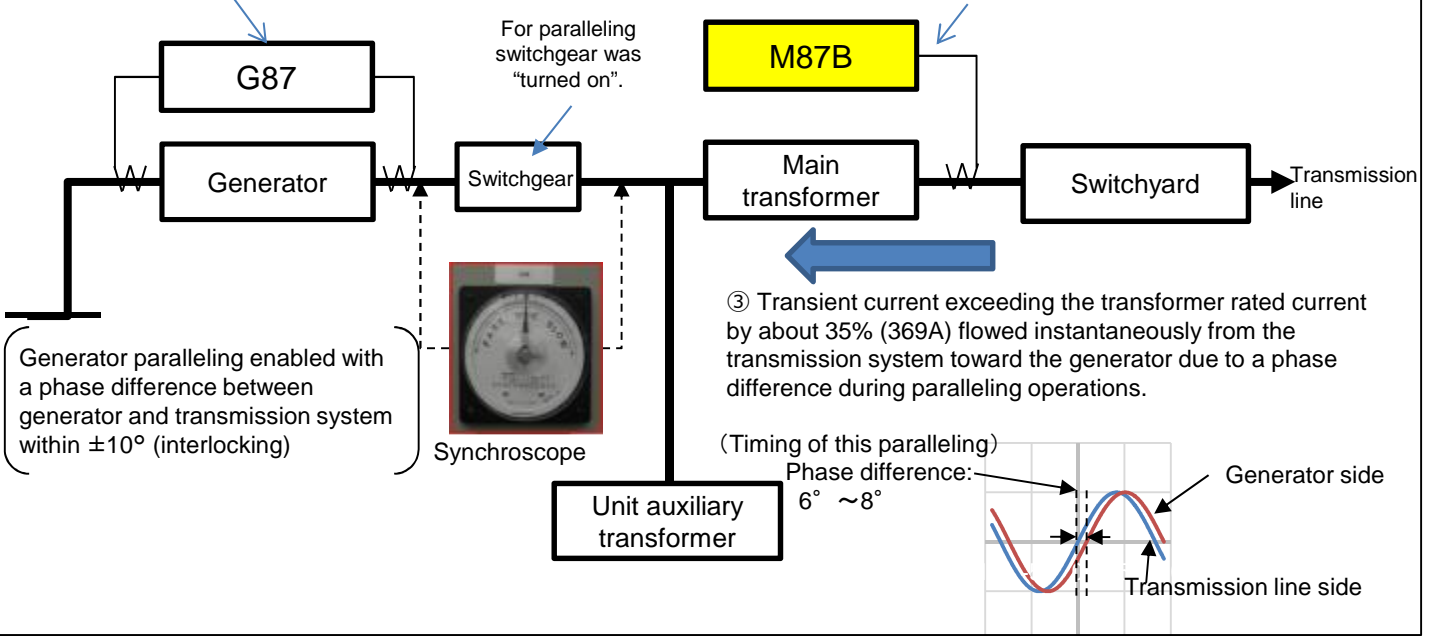
## <Generator paralleling operations>

### ① Relay (G87)

- Replaced during this refueling outage period
- Planned to place in service after confirming its integrity at 5% generator output

### ② Relay (M87B)

- Tentatively used as an alternative to G87
- Actuation point was set at 30% (316A) of main transformer rated current (1,054A).

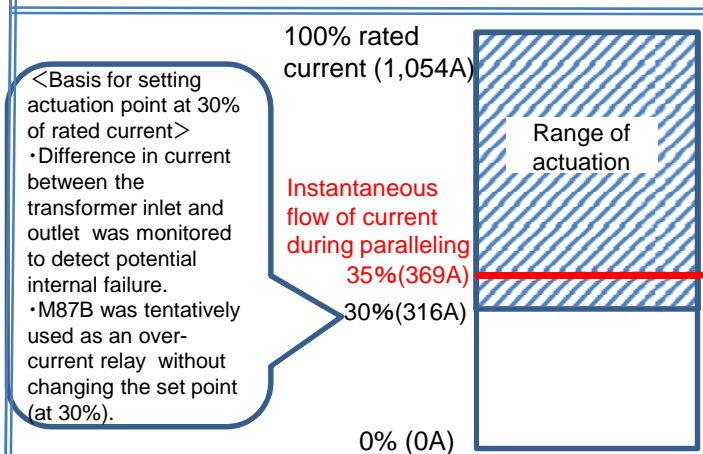
### Before this event

- (1) When it was decided to tentatively use M87B as an alternative after the replacement of G87, its actuation point was set without considering potential transient current.
- (2) The manufacturer was not asked to assess potential effects of transient current in setting M87B actuation point when they received an order for the replacement of the relay panel.
