Causes of and Corrective Action against Water Leakage within the Controlled Area at Takahama Unit 4

February 22, 2016
The Kansai Electric Power Co., Inc.

Water Leakage within the Controlled Area at Takahama Unit 4

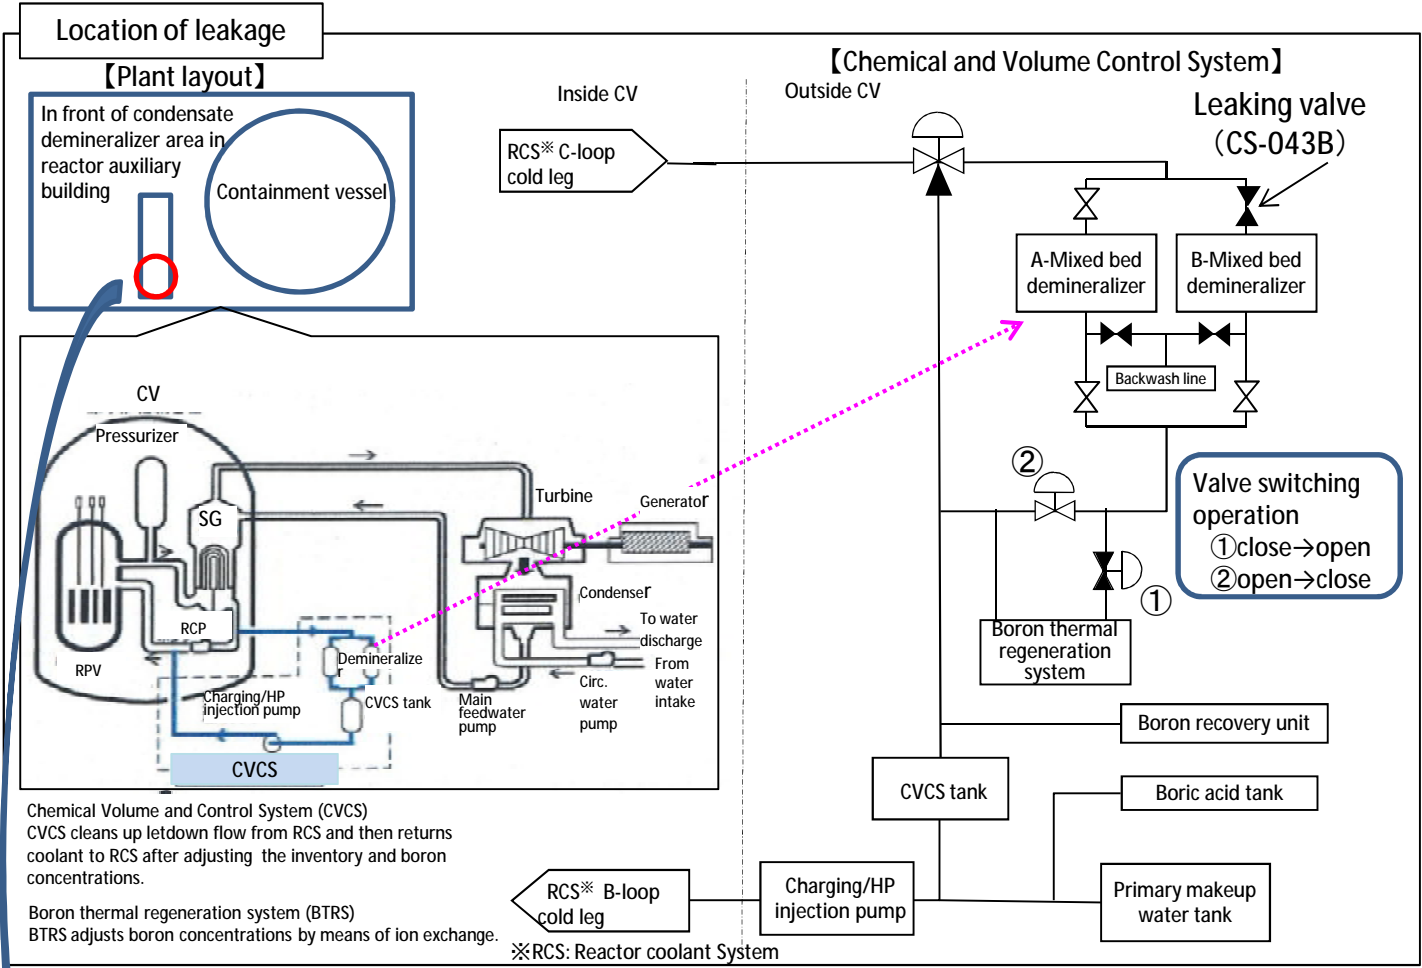
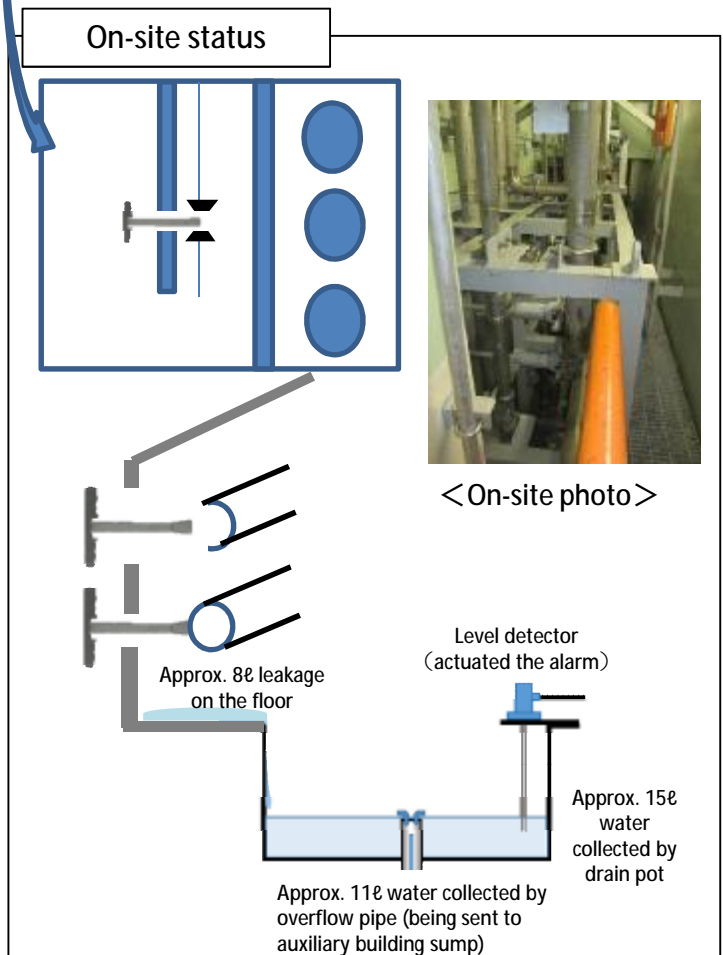
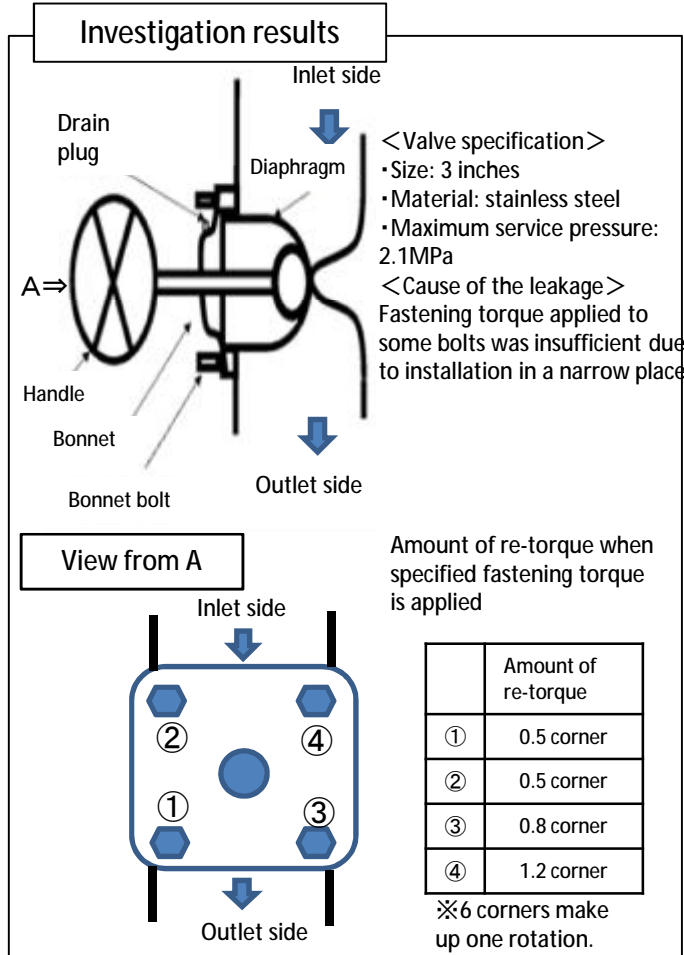
- Investigation of areas surrounding the puddle in front of the condensate demineralizer area observed water drops attached in the vicinity of 2 valves located above the puddle (inlet and outlet valves of B-mixed bed demineralizer).

- The systems surrounding B-mixed bed demineralizer including the 2 concerned valves were isolated and pressurized to identify the leaking point. When pressure reached 1.1MPa, water leaking between the valve casing and diaphragm sheet of B-mixed bed demineralizer inlet valve (CS-043B) was observed (approx. 0.7ℓ /minute).
- After being pressurized to nearly the design pressure, there was no leakage in the B-mixed bed demineralizer outlet valve. Accordingly, it was determined that the leaking point was in the B-mixed bed demineralizer inlet valve (CS-043B).

- We checked the maintenance record and confirmed that overhaul inspection of the concerned valve had been conducted during the 18th refueling outage inspection (August 2008 through January 2009).
- The concerned valve was disassembled and overhaul inspection was conducted again and it was confirmed that there were no foreign objects or defects in the interior of the valve casing and there was no degradation in the diaphragm sheet.
- We checked the status of fastening of 4 valve bonnet bolts and found that the bolts were not uniformly fastened with less fastening torque applied to some bolts.
- As a result of the field investigation, we found that the valve had a horizontal driving shaft and was installed in a narrow place. Therefore, it is estimated fastening torque applied to some bolts was insufficient due to installation of the valve in a narrow place.

- We checked the measurements taken by the pressure gage installed upstream of the B-mixed bed demineralizer inlet valve and confirmed that there was a temporary pressure increase (from approx. 2.3MPa to approx. 3.0MPa) during the operation before alarm actuation to pass the coolant through the boron thermal regeneration system.
- Verification of past records revealed that there had been temporary increases in the pressure when feeding water to the boron thermal regeneration system.

It is estimated that fastening torque applied to some bonnet bolts of the B-mixed bed demineralizer inlet valve was insufficient partially due to the status of installing the valve in the field. As a result, water leaked from the concerned valve as the system

pressure temporarily increased during water feeding to the boron thermal regeneration system from the chemical volume and control system.

We will replace the diaphragm sheet of the concerned valve with a new one and will verify if the concerned valve and other valves of the same type (i.e., having the horizontal driving shaft), through which reactor coolant passes, are appropriately fastened or not.

We will also add notes in the valve operation manual about valve bolt fastening operation, including the selection of tools suitable to the place of operation.

In addition, we will include a description in the operating procedure about the operation to feed the reactor coolant to the boron thermal regeneration system from the chemical and volume control system(CVCS) while keeping the pressure of CVCS letdown water at a low level (approx. 1.0MPa) in order to mitigate the influence of pressure fluctuation.
