Takahama Unit 4 Automatic Reactor Trip (No.3)

March 1, 2016

The Kansai Electric Power Co., Inc.

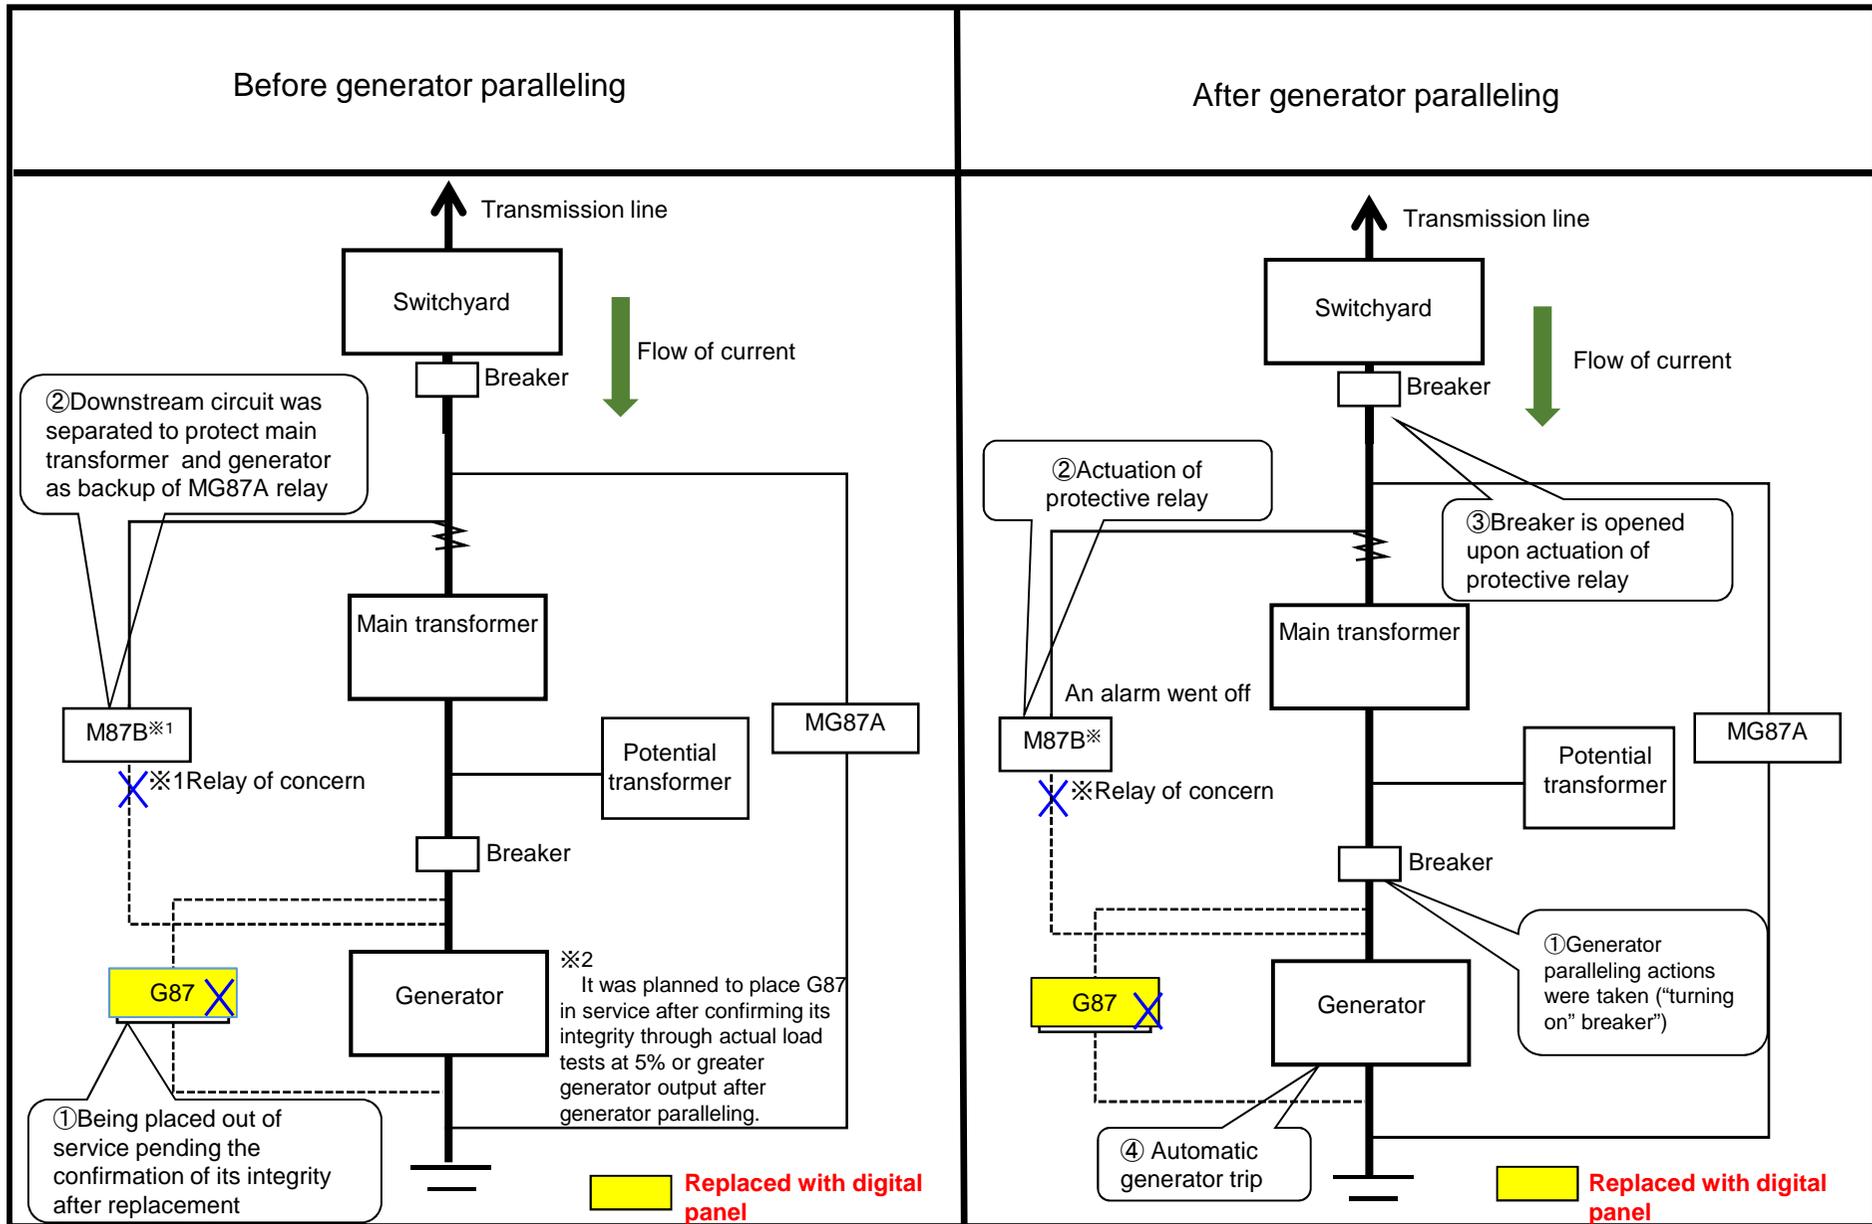
Status of Generator/Main Transformer Protection before/after Generator Paralleling

The generator transformer protective relay panel was replaced with an upgraded digital panel in August 2011 while Takahama Unit 4 was undergoing the periodic

outage inspection. After the replacement, the use of protective relay G87 for the detection of generator internal failure was made suspended until its integrity was confirmed through initial load tests (at 5% generator output) after generator paralleling.

Besides, the configuration of the protective relay M87B, which was originally intended to detect main transformer internal failure, as well as the protective relay MG87A for the detection of generator internal failure, which also had a function to protect the main transformer through the generator as a package, was changed so that they were able to detect any failure in the generator and main transformer as a backup protective circuit.

Meanwhile, as a result of checking the record of current values flowing through the protective relay M87B, we confirmed that the current flowing into the generator from the transmission line immediately after generator paralleling exceeded the set point at 30%, which triggers the protection and trip of the generator.
